Washington State  
School Seismic Safety Assessments Project

# CENTRAL ELEMENTARY SCHOOL MAIN BUILDING Hoquiam School District #28

SEISMIC UPGRADES CONCEPT DESIGN REPORT

June 2021

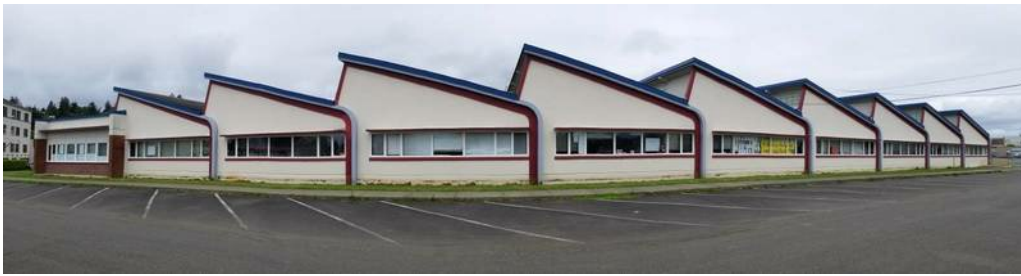
Deficiency	Description
Overturning	The narrow piers at the long walls of the sawtooth roof structure are shorter than the 8'-9" calculated minimum length for compliance.
Shear Stress Check	The narrow concrete piers at the longitudinal walls of the sawtooth roof structure appear to be overstressed.
Spans	The gymnasium roof appears to be straight sheathed and the spans between lateral-force-resisting elements exceed 24 feet. The underside of a straight-sheathed roof is also visible in the mechanical room. The locations of shear walls at the north wing are unknown, but assuming no interior shear walls, that area is also not compliant.

**Figure 1-7. Panoramic view of the original saw-tooth roof classroom wing.**

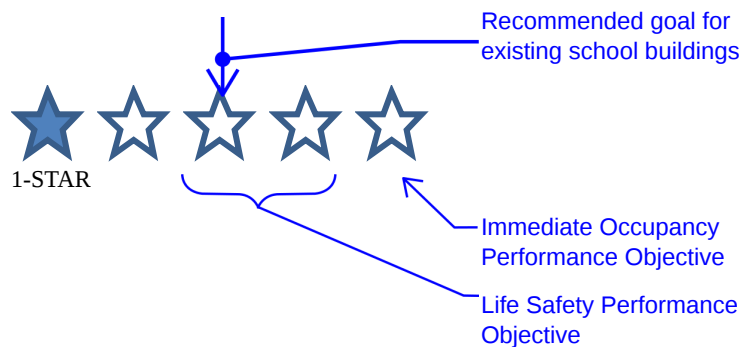
The structural safety star-rating below is a preliminary rating based on the information available for this study. The geologic checklist items have been excluded from the structural safety star-rating. If a building's structural safety star-rating is to be improved, it may also be necessary to further assess the geologic conditions of the building site. Determining the final star-rating of a building is intended to be an iterative process and preliminary ratings will often times be conservative until more field investigation, structural analysis, and engineering judgment is performed by a structural engineer. The intent in providing a preliminary star-rating as part of this study is to provide school districts with the action lists below to further improve the seismic performance and safety of the buildings that were assessed. The tables below indicate the Unknown (U) or Noncompliant (NC) structural seismic evaluation items that should be mitigated or further investigated to improve the Earthquake Performance Rating System (EPRS) structural safety rating for this building.

EPRS Structural Safety Rating for Central Elementary School, Main Building:

1-STAR
